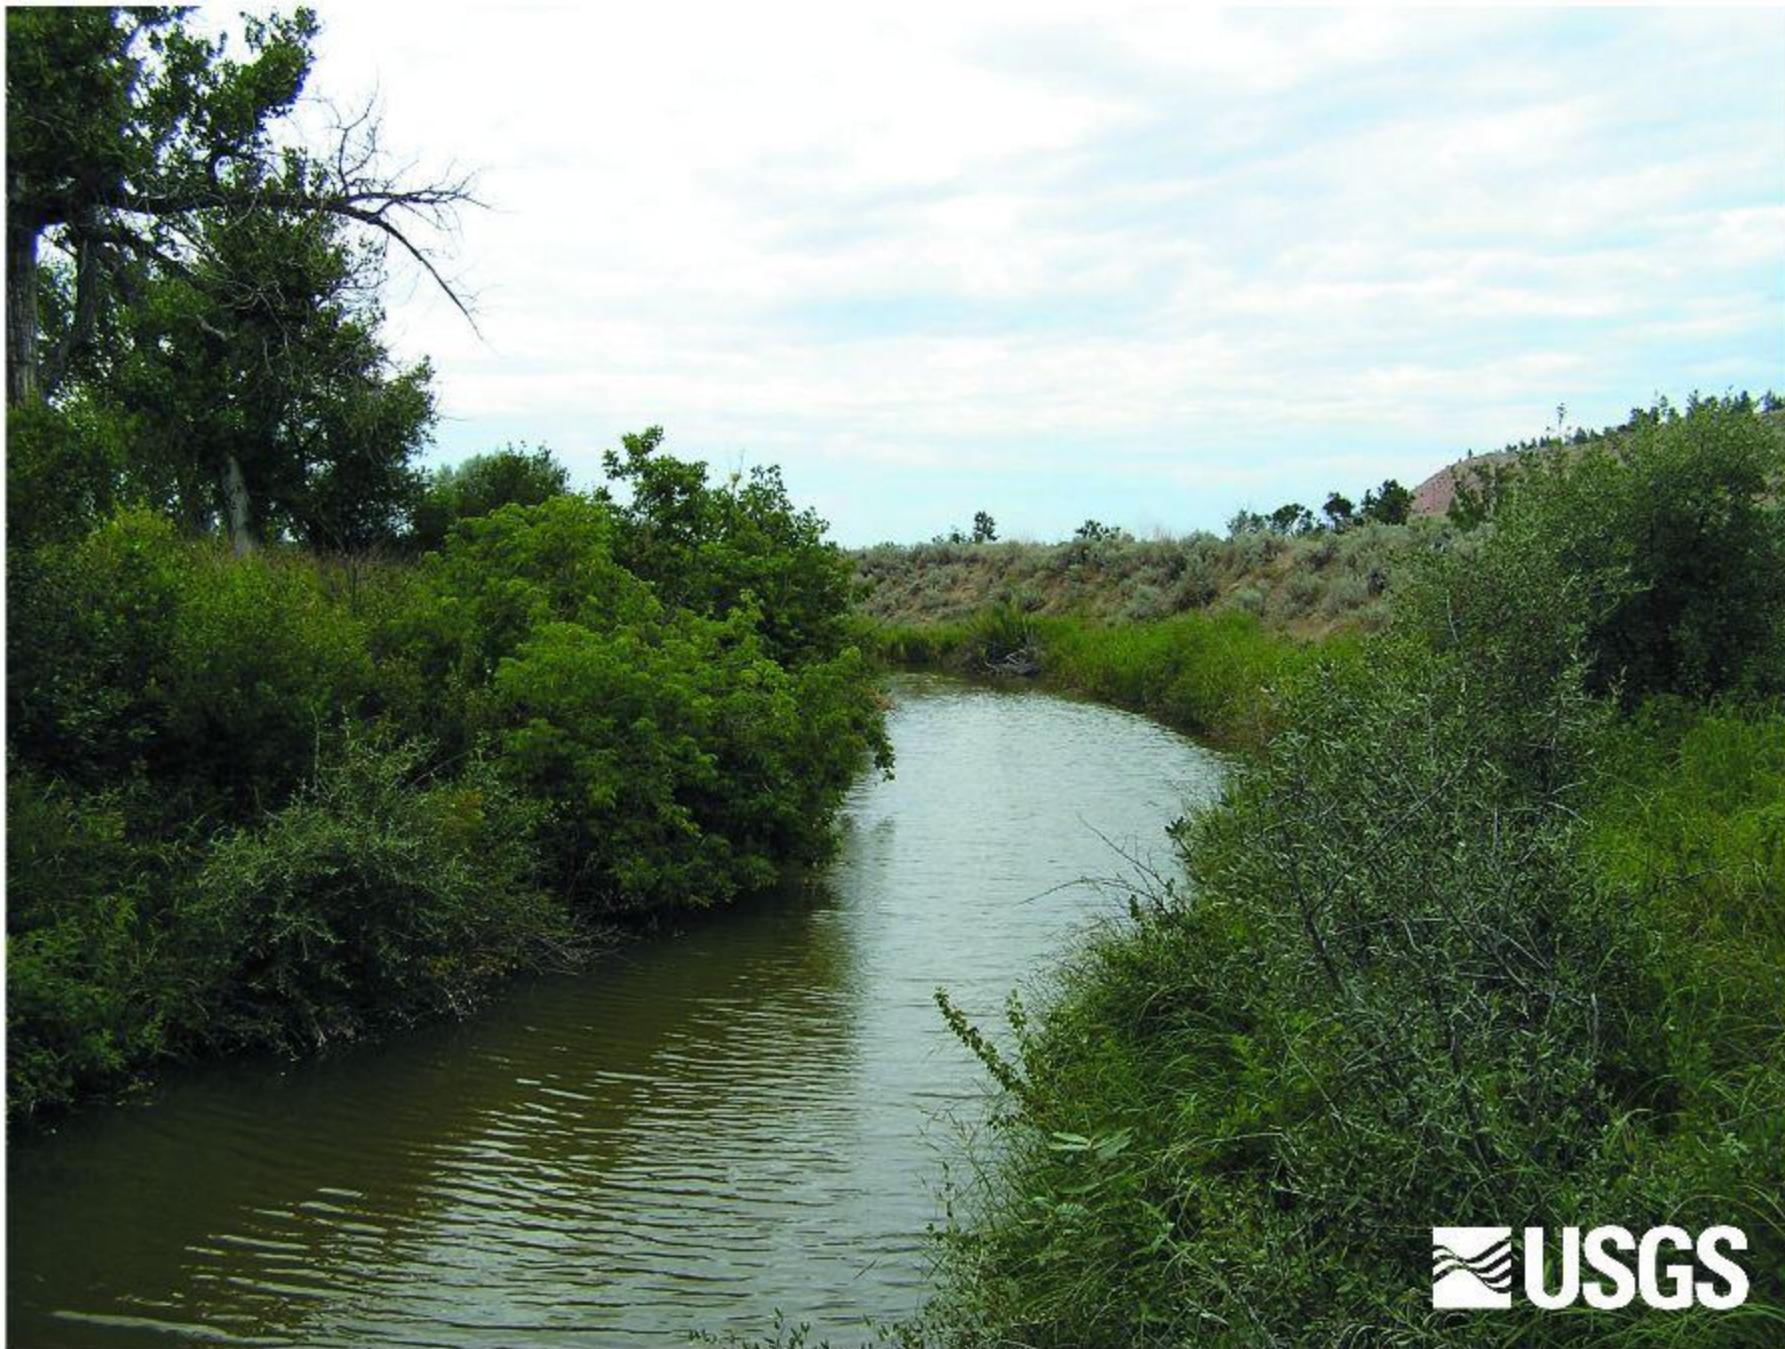
Otter Creek at Ashland, Montana, July 2004. View is looking downstream from the gaging station. The stream at this location was frequently affected by backwater from a beaver dam, and gaging streamflow was difficult. During October 2004, the gage was moved upstream to a site unaffected by beavers.
